SOC1-97/1

**EB CURING OF VARTM FABRICATED MARITIME
COMPOSITE STRUCTURES**

Contract USZA22-97-P-0013
CDRL A002

DAMILIC Corporation
14670 Southlawn Lane
Rockville, MD 2085

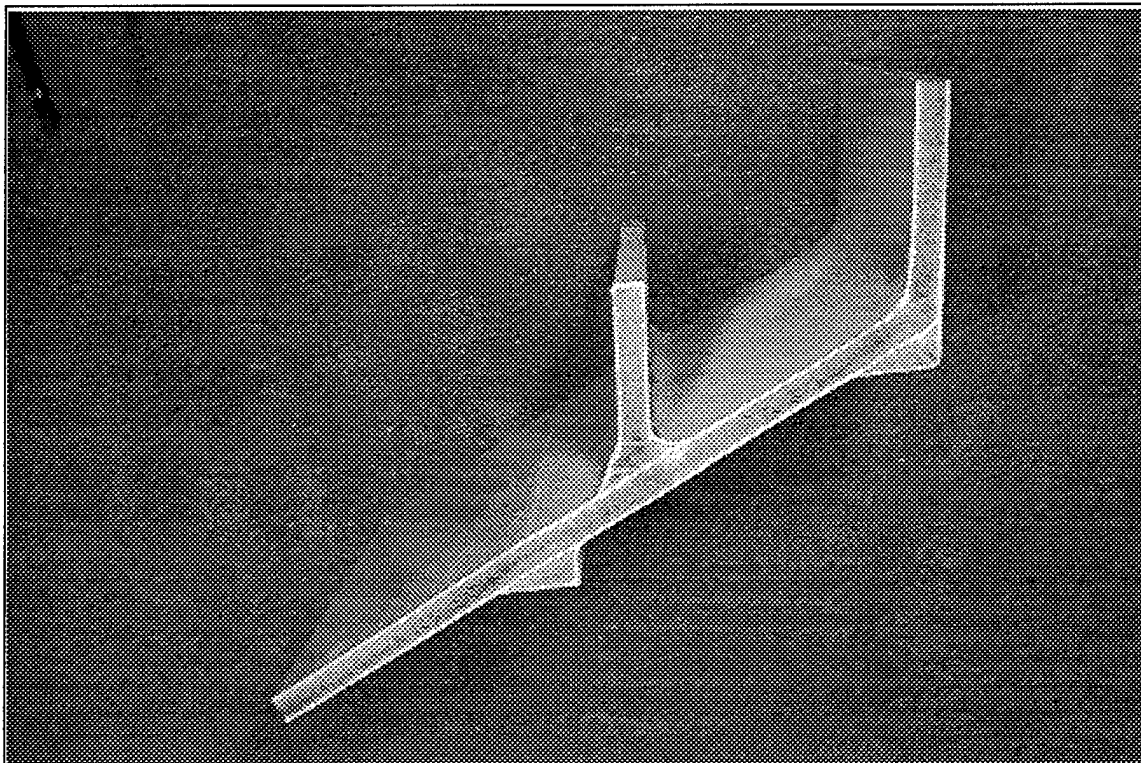
Figure 1: Demonstration section of boat hull cured with EB radiation.

The part was layed up on inexpensive wood/formica tooling. A vacuum assisted resin transfer molding technique was used for resin infusion. Immediately after resin infusion, the part was irradiated as required to achieve satisfactory cure. Although the cure was sufficient throughout the part, delamination was observed in several regions of the part. The delamination zones appear to be "resin starved", implying that the delaminations resulted from the resin infusion process, not the EB curing step.

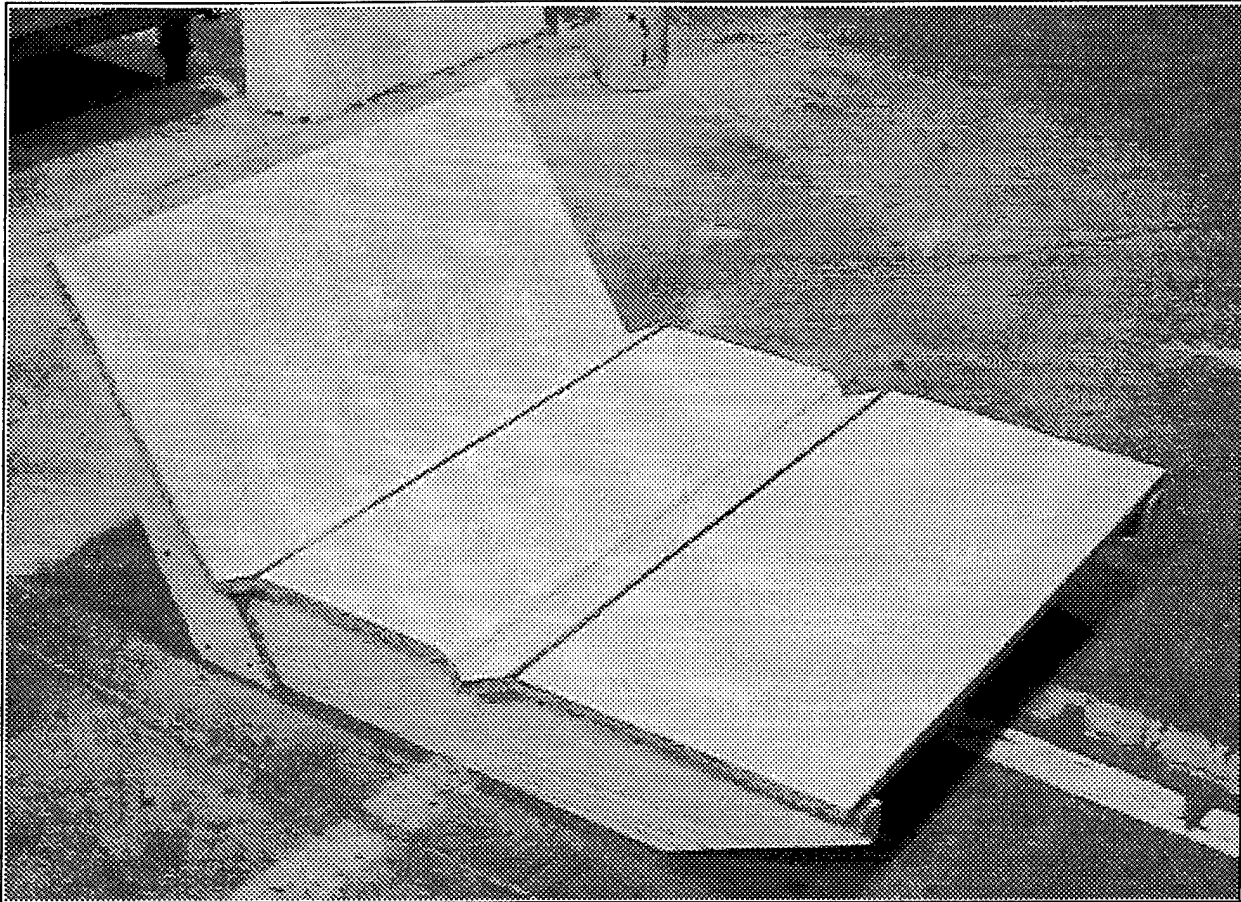
Because EB cures can be achieved at room temperature, no special consideration for high temperature operation was included in the tool design and construction. Unfortunately, the elevated temperature (ref. Figure 7), resulting from exothermic reaction during cure, exceeded the rated operating temperature of the epoxy fillet. This resulted in loss of vacuum during the EB cure, exacerbating the part's delaminations, and some local contamination of the hull outer surface with epoxy. This particular tool will require some minor rework for additional use. However, the use of a more appropriate epoxy would render this tool reusable for many production runs.

Figure 4: Tool was constructed of wood and Formica.

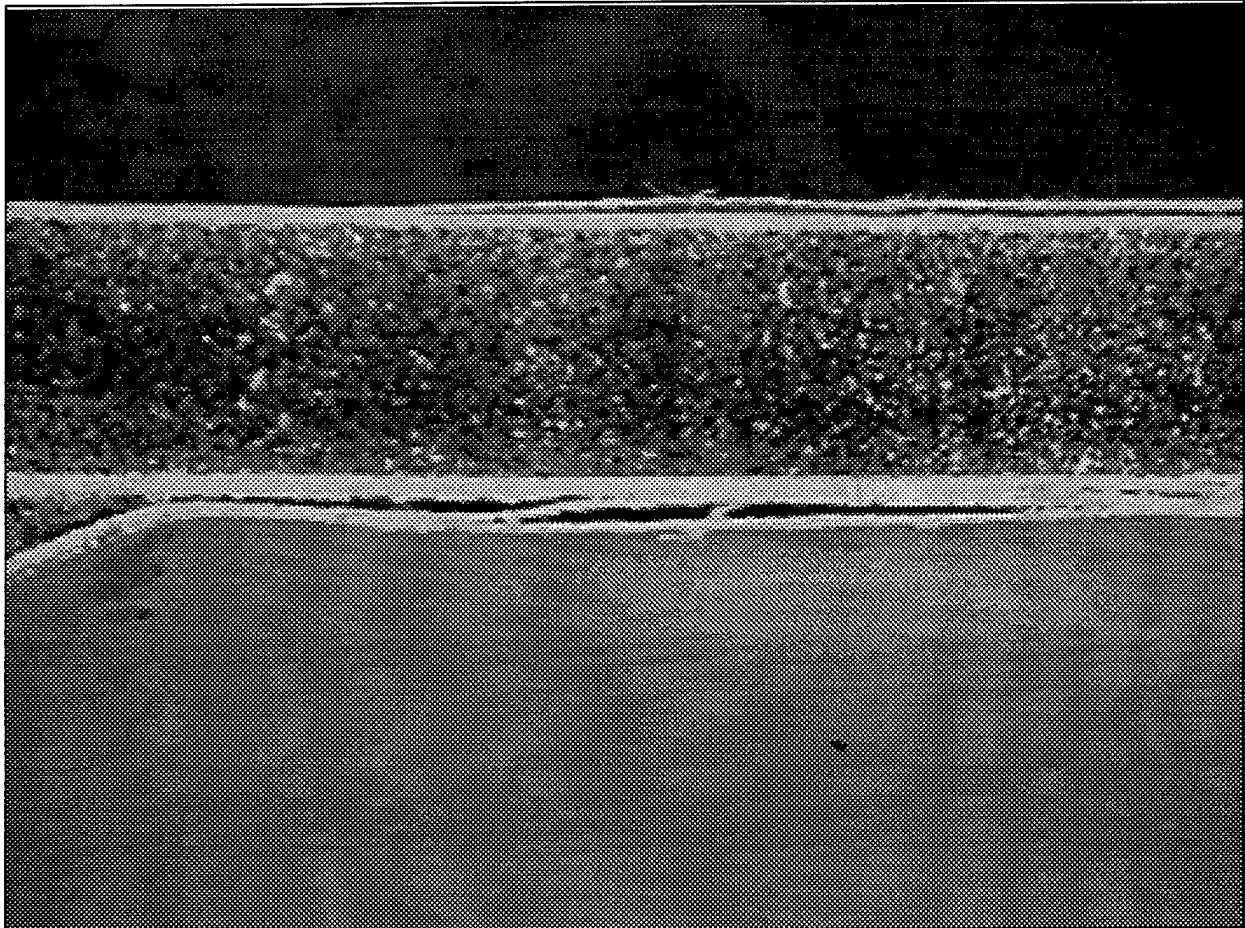
- 1) An elliptical area approximately 5" x 10" between the individual Kevlar fabric layers on the inside surface of the hull (i.e. the side with the longitudinal support structure) was observed immediately after removing the part from the tool. This is the upper delamination shown in Figure 9.

2) A 5" x 18" area roughly rectangular in shape between the hull plies and the strake over-plies (between spray strake and boat side). This is the lower delamination shown in Figure 9.

Figure 9: Both delamination and stains from the tooling were observed.

The cause of the delamination appeared to be a lack of proper wetting. Samples of fiber were removed for microscopic evaluation. Optical inspection was not more conclusive, so further magnification to 2000 X using a scanning electron microscope confirmed insufficient wetting in the region of delamination (Figure 10), while the sample from a region having no delamination exhibited complete coverage of the fibers with resin (Figure 11).

- 1) Thin gel coat gave the appearance of several scratches.
- 2) A variety of discolorations that are typical of EB curing were also observed, particularly in the foam core. However, there is no apparent change in color for the cosmetically important gel coat finish.
- 3) Regions of radius formed by the tooling have epoxy on the gel coat surface as described on page 7 (see Figure 9).

Although the final EB cured part did exhibit several flaws, they appear to be unrelated to the EB process. In fact, our evaluation of the delaminations and the general imperfections strongly indicate that minor refinement of the resin lay-up and infusion process would remove all of the observed problems. Further, it is believed that simple modification of the resin formulation could result in a reduction of dose, a reduction of the styrene content, and an improvement in the performance properties of the matrix.

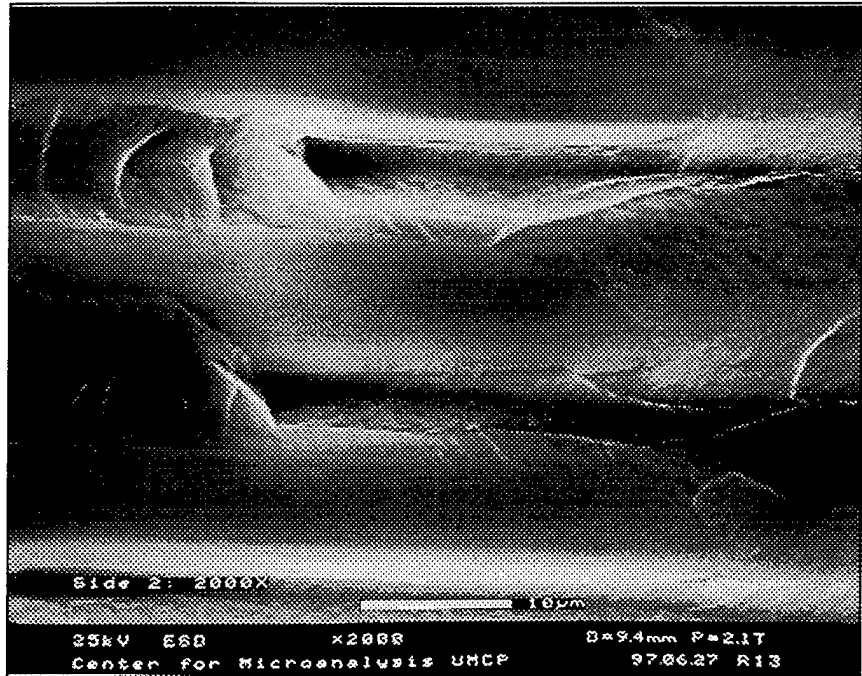
Figure 10: Fibers in region of delamination show lack of resin coverage.

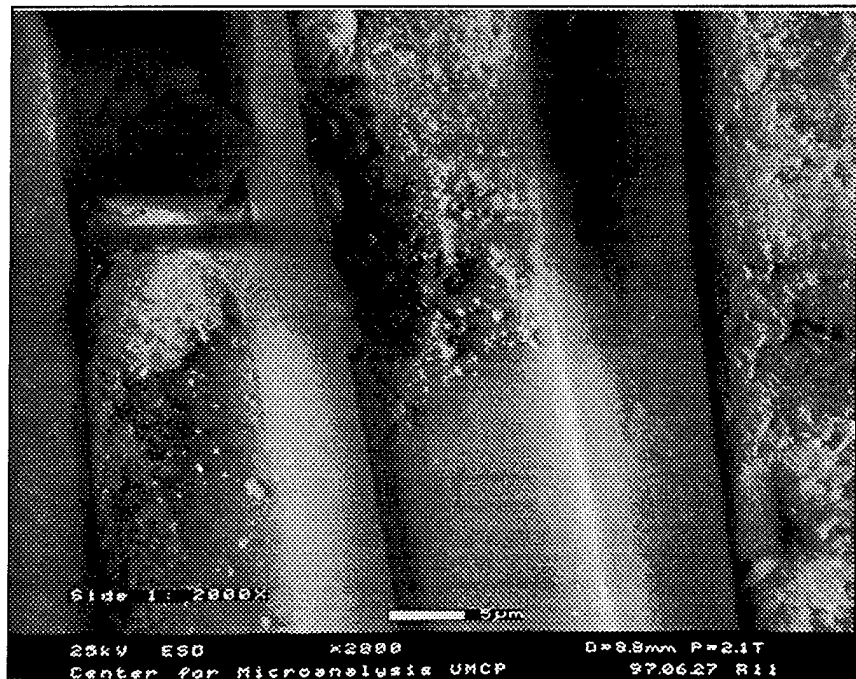
Figure 11: Fibers in region with no delamination have complete resin coverage.

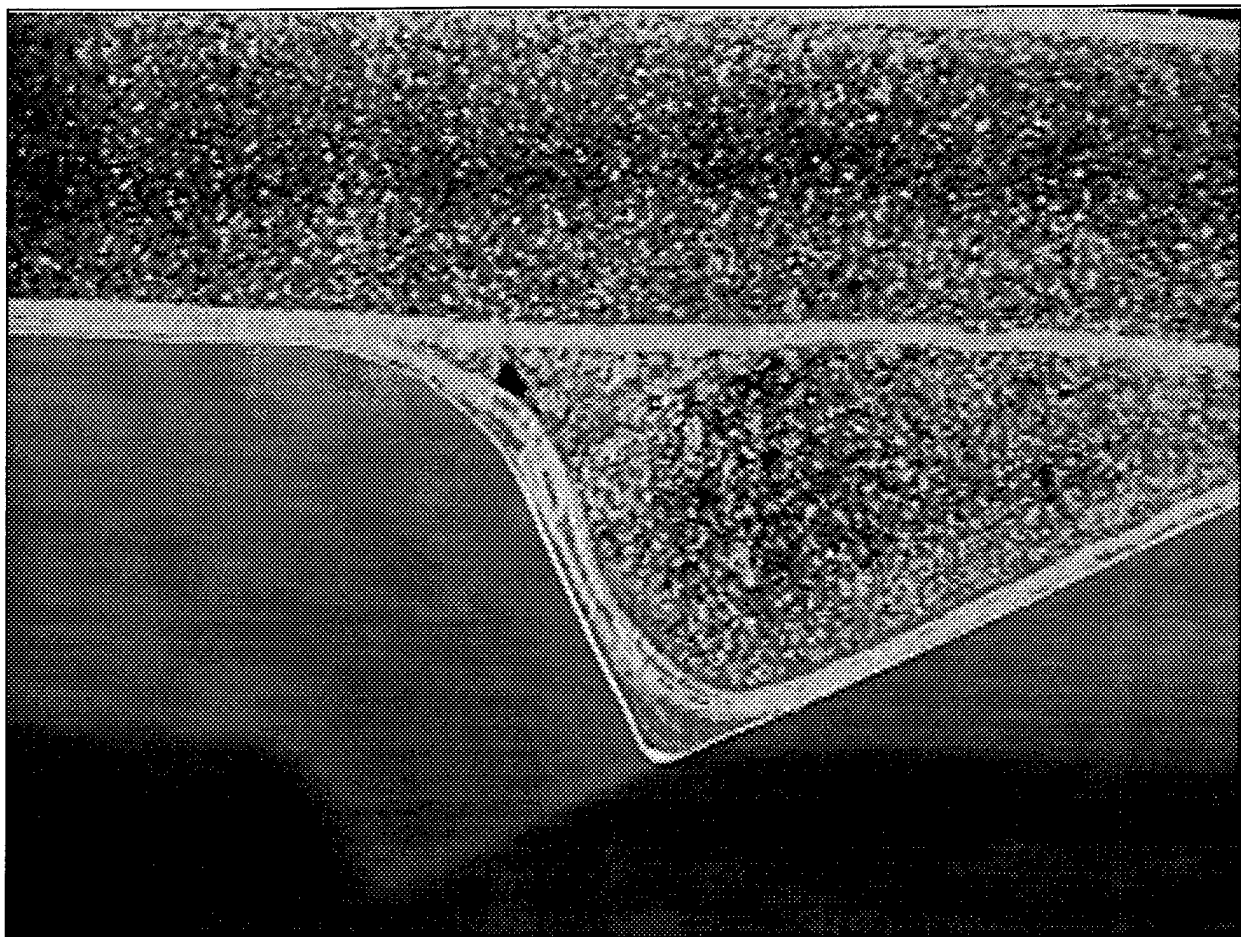
In addition to the regions of delamination, there are voids between the foam core and adjacent plies at the stake (see example in Figure 12) and longitudinal support. All regions with voids and delamination appear to be resin starved.

Figure 12: Void in the spray strake
